# ARPA Coupling Program on Stress-Corrosion Cracking (Thirteenth Quarterly Report)

*Physical Metallurgy Branch  
Metallurgy Division*

March 1970

**NAVAL RESEARCH LABORATORY**  
**Washington, D.C.**

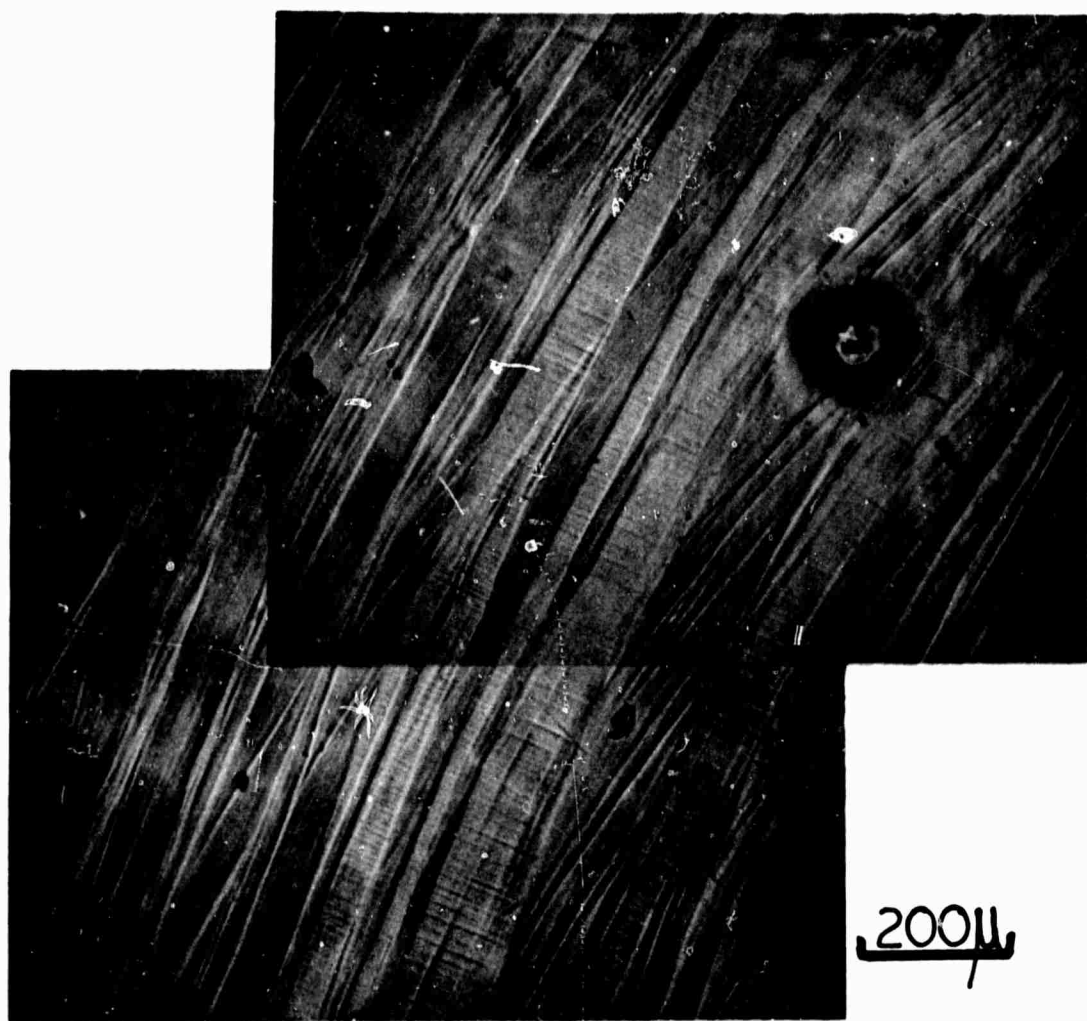
Fig. C-7 - Slip lines on the top face of a crystal aged at 135°C for 12 hours ( $\gamma \approx 0.5$ ).

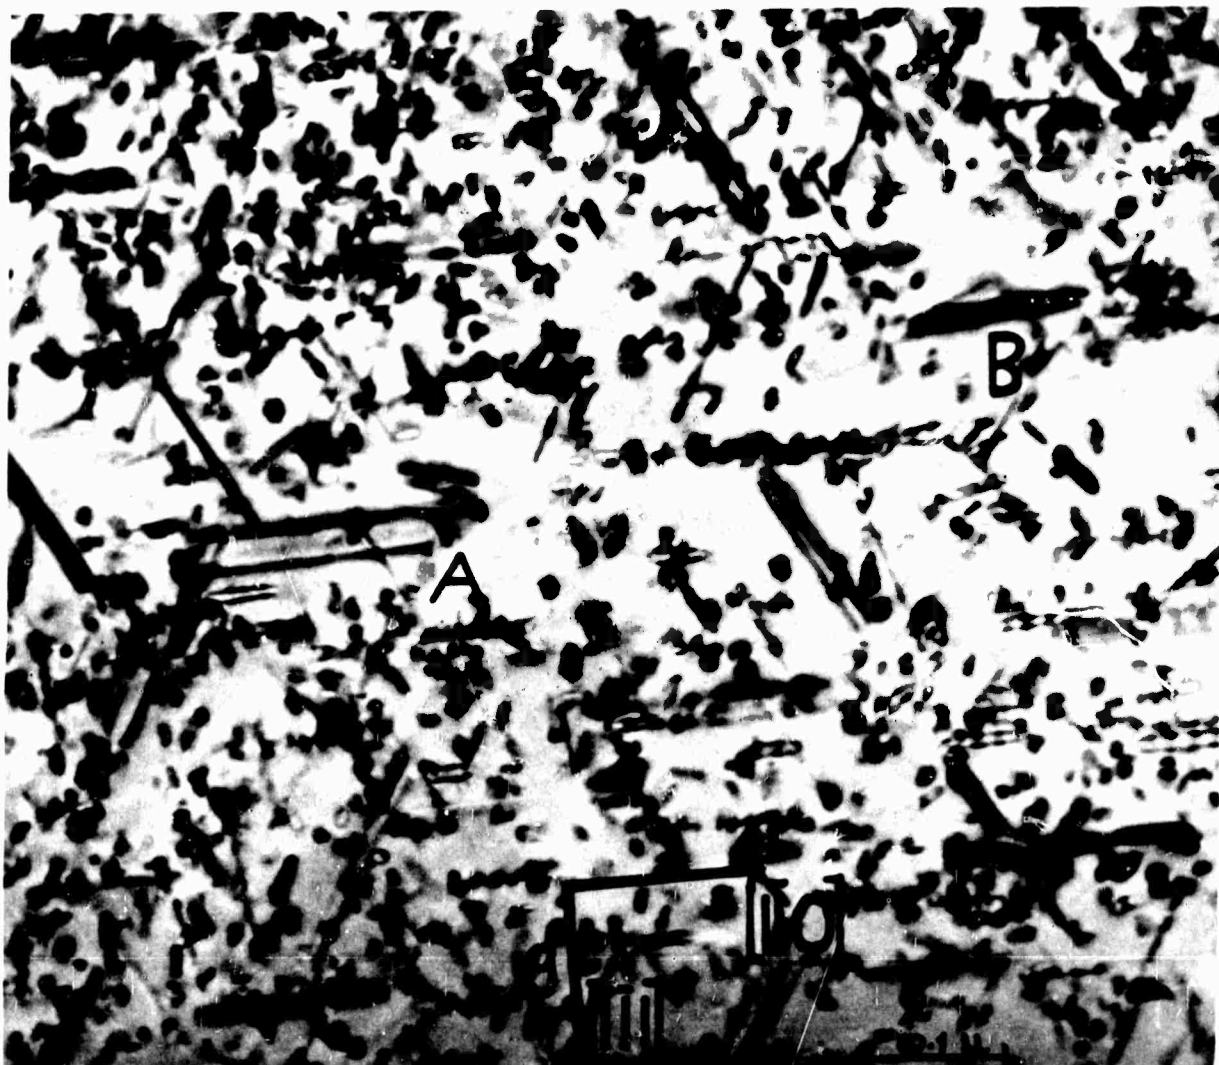
A. Dislocation ring contrast

B. Strain field contrast

Fig. C-12 - The precipitate morphology observed after aging for 80 hours at 135° C.

Figs. C-12 and 13 show the  $\{111\}$  plane of a specimen aged for 80 hours at 135° C. The precipitate morphology is very complex. Approximately fifty percent of the precipitates seem to be lath shaped while the remainder are not characterized by any well-defined geometry. In Fig. C-12 several large precipitates which lie in the plane of the foil, e.g., at A (this is a type 1 precipitate), show dislocation ring contrast, while pre-precipitates at B in Figs. C-12 and 13 exhibit well-defined strain fields with the line of no contrast perpendicular to  $\bar{g}$ . This indicates that these precipitates possess a coherent or partially coherent interface.

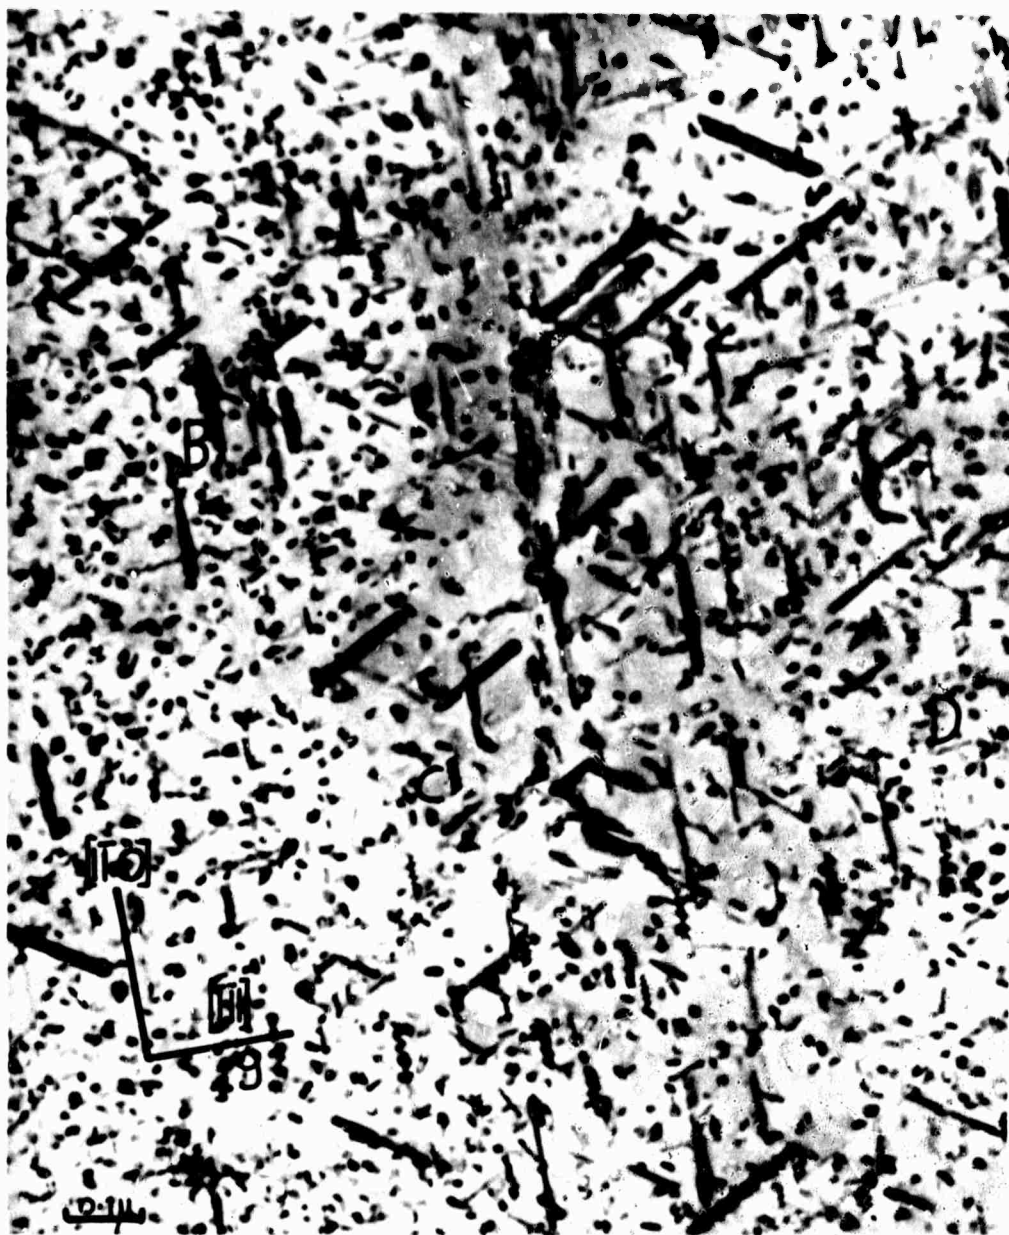
C. Displacement fringe contrast of type 1 precipitates

Fig. C-13 - The precipitate morphology observed after aging for 80 hours at 135°C.
